Manhole Inspection Summary

Manhole # **S11GG_042MH**

Location Address: **3000 BAKER ST**

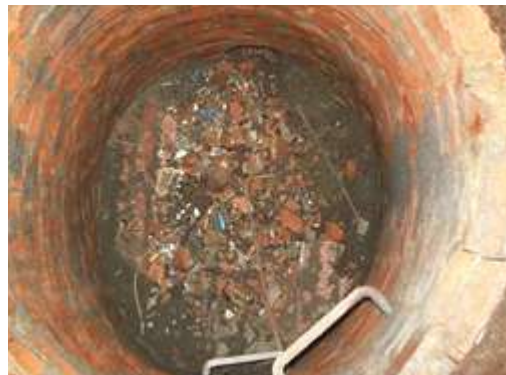
Top View

Condition: **Sound**

Frame Offset: **0** (in.) Condition: ☒ Sound ☐ Cracked ☐ Leaks

Condition: ☒ Sound ☐ Cracked ☐ Root Intrusion ☐ Loose Brick ☐ Deteriorated

Condition: ☒ Sound ☐ Cracked ☐ Root Intrusion ☐ Deteriorated ☐ Leaks ☐ Debris

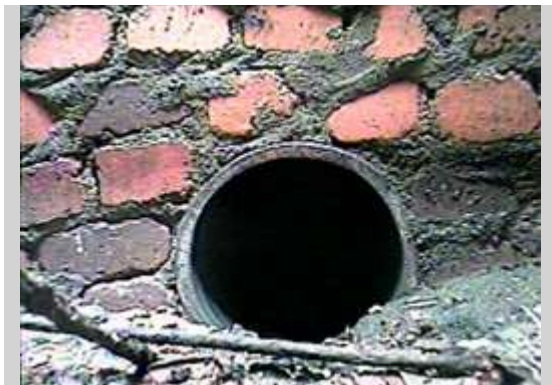
12 O'Clock Outflow

8 in. Circular Gravity Sewer
Pipe Out @ 12 O'Clock

Pipe Material: **Clay** ☐ Pipe Lined

Invert Depth: **5.76** (ft.) Flow Characteristics: **None**

Deposits: ☒ None ☐ Mud ☐ Sludge ☐ Debris ☐ Grease

Infiltration: **None** Pipe Seal Cond: **Sound**
